LuK 0562

SERVICE INFO

Installation notice

Guide tube issues

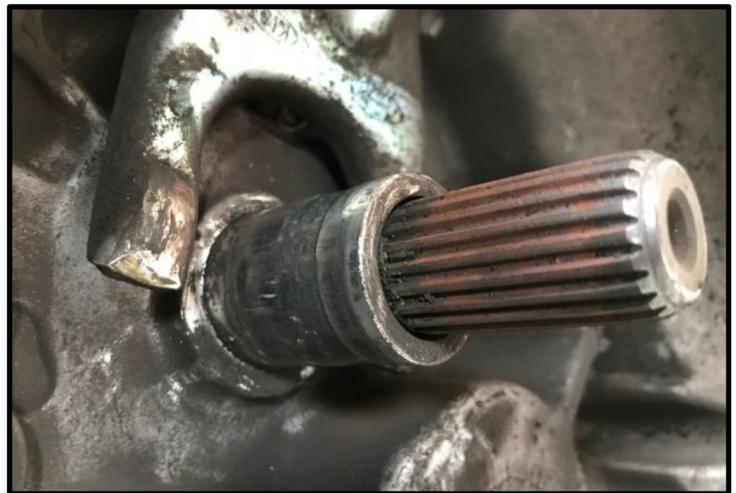
Excessive wear to the guide tube can result in heavy clutch operation, clearance problems or failure of the release bearing or fork.

As with all vehicles using a release bearing and fork assembly it is crucial that the guide tube is in a servicable condition. On many of the Kia range the guide tube is an integral part of the bellhousing and can only be replaced as a complete assembly.
